Iain S. Walker¹ and Max H. Sherman¹

Sealant Longevity for Residential Ducts

Reference: Walker, I.S. and Sherman, M.H., “**Sealant Longevity for Residential Ducts**,” *Durability of Building and Construction Sealants and Adhesives, ASTM STP 1453*, A. Wolf Ed., American Society for Testing and Materials, West Conshohocken, Pa.

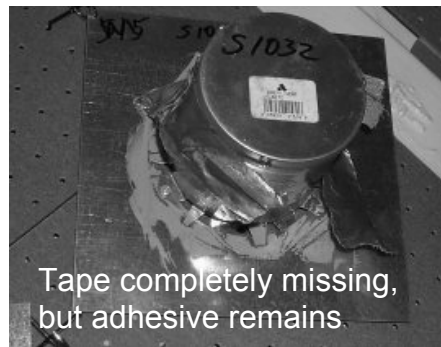
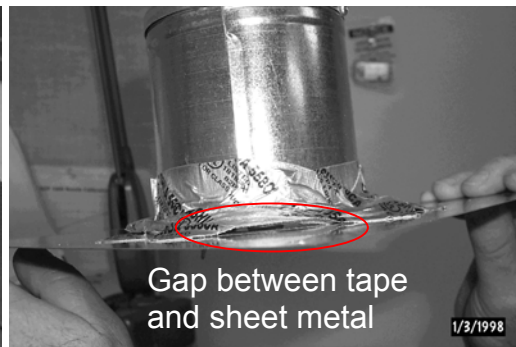
Figure 2 - *Example failures of the collar-to-plenum joint.*

Only cloth-backed rubber adhesive tapes failed. However, the range of time to failure for these types of tape was large - with some failing in a few days and others failing slowly over several weeks. Figure 2 illustrates several of the failed collar-to-plenum joint test samples. The failure of these samples was due to a combination of factors. Some samples exhibited obvious adhesive failure, with the adhesive flowing out of the seal, or hardening and becoming brittle so that it was no longer sticky. The brittle failures sometimes led to catastrophic failure where the tapes fell off the sample completely, leaving a layer of adhesive on the joint. Delamination was common, mostly because the backing shrank more than the adhesive or the reinforcing mesh. One sample failed even before it was installed in the test apparatus. The sample was prepared for testing and placed on a workbench in the laboratory for a week. The tape had peeled itself off the joint in an attempt to return to its natural shape. Some samples were removed from the apparatus after 100 days of testing to make space on the apparatus for new samples. The removed samples were those that showed insignificant changes (no failure) in the 100 days of testing.

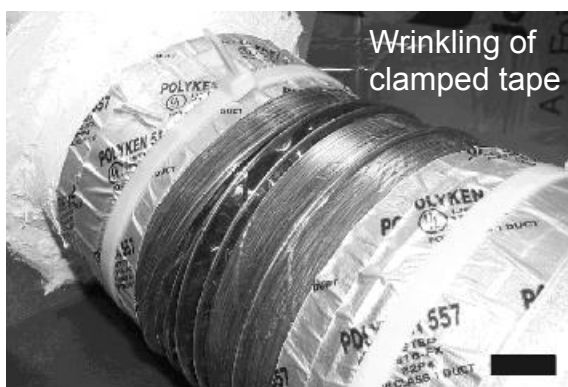
Figure 7 - *Illustration of visual degradation of duct tape.*

as discoloration, wrinkling, and oozing; major deteriorations were shrinking, peeling, delamination, and cracking. Figure 7 shows the deterioration of one of the samples with clamping, and two continuous wraps of duct tape. After the first month of aging at $93\pm 3^{\circ}\text{C}$ ($200\pm 5^{\circ}\text{F}$), all 18 samples showed the following deterioration, increasing with time:

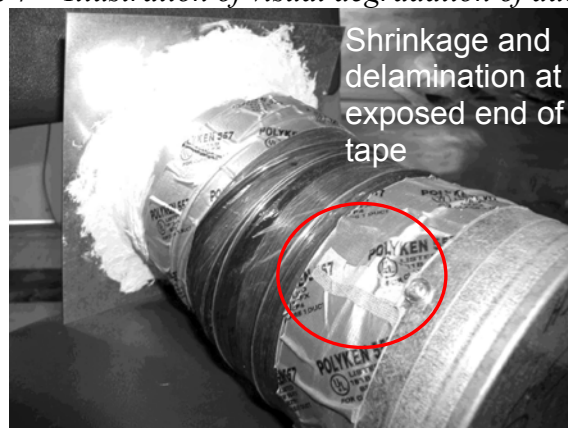
Figure 8 - *Shrinkage and delamination for an unclamped sample after 5 months of testing.*

- shrinkage and delamination among the unclamped samples (Figure 8)
- oozing of the adhesive layer in the foil-butyl tape samples (Figure 9)
- little shrinkage and delamination in the strapped samples
- discoloration of the plastic strapping in the clamped samples

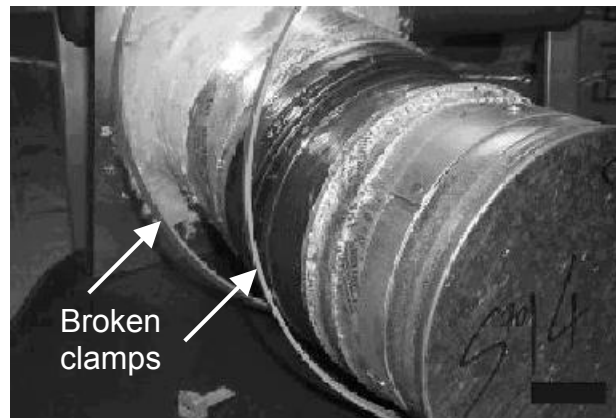
Figure 10 - *The failed plastic strapping on one of the flexible core to sheet metal collar samples after four months of testing.*

The discoloration of the plastic strapping was an indication of progressive deterioration that led to a total failure in one case after four months of testing: the plastic clamp cracked open due to the increased brittleness of the plastic (Figure 10).

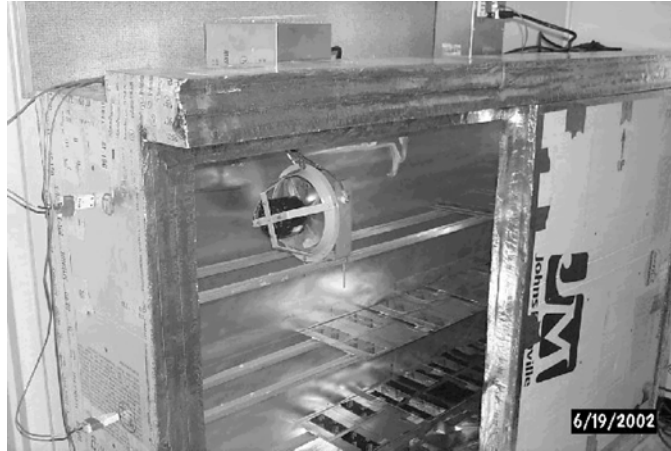
Figure 12 - *The high temperature baking apparatus for UL 181B testing.*

within 2.5°C (5°F) of the target temperature of 100°C (212°F). Rather than testing sample duct connections, the baking tests in this phase used tapes that are applied to thin flat substrates of materials found in duct systems. Figure 12 shows the circulator fan and the racks inside the baking apparatus.

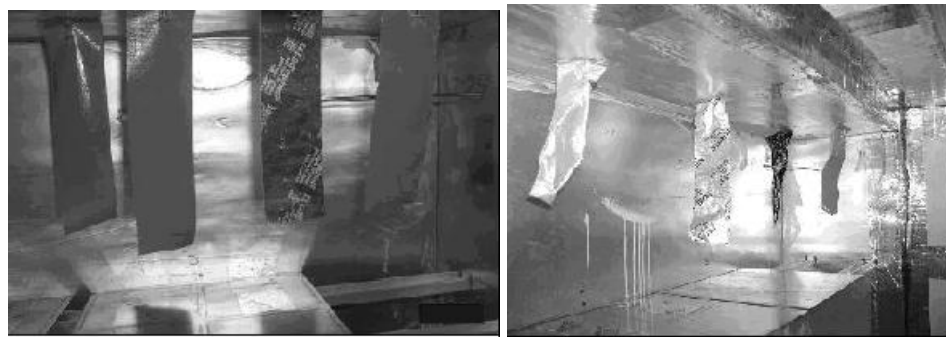
Figure 14 - Hanging samples in the high temperature baking apparatus before testing (left) and after three weeks of testing (right).

For each duct tape, twelve tape specimens were made by applying a strip of tape to three 100 by 100 mm (4 by 4 inch) samples of each of the following four materials: aluminum foil, polyethylene, polyethylene terephthalate (PET), and sheet metal (steel). Another 100 by 100 mm (4 by 4 inch) control sample of each of the substrate materials is included in the specimen set without applying the tape to it. The control sample serves as a means to quantify the deterioration attributed to the substrate in isolation from the duct tape. A specimen set in this test, therefore consists of three similar samples and one control sample, all carried by a sheet metal tray in the oven (Figure 13). Because the substrates used in this test are very thin and lightweight, they are attached from two sides to the sheet metal tray so that the fan cannot blow them away from their locations. In addition, we also placed hanging samples in the baking apparatus. These samples were attached to the top of the apparatus and had no substrate. Both the finished and the adhesive sides of the tape were exposed to the heated air, as shown in Figure 14. The samples in the baking test were tested for 60 days, with visual inspection once a week.
